Maintenance Welding in Nuclear Power Plants/III

CONFERENCE
PROCEEDINGS

MAINTENANCE WELDING IN NUCLEAR POWER PLANTS III

STEAM GENERATOR AND PIPE REPLACEMENT OF GERMAN LIGHT WATER REACTORS

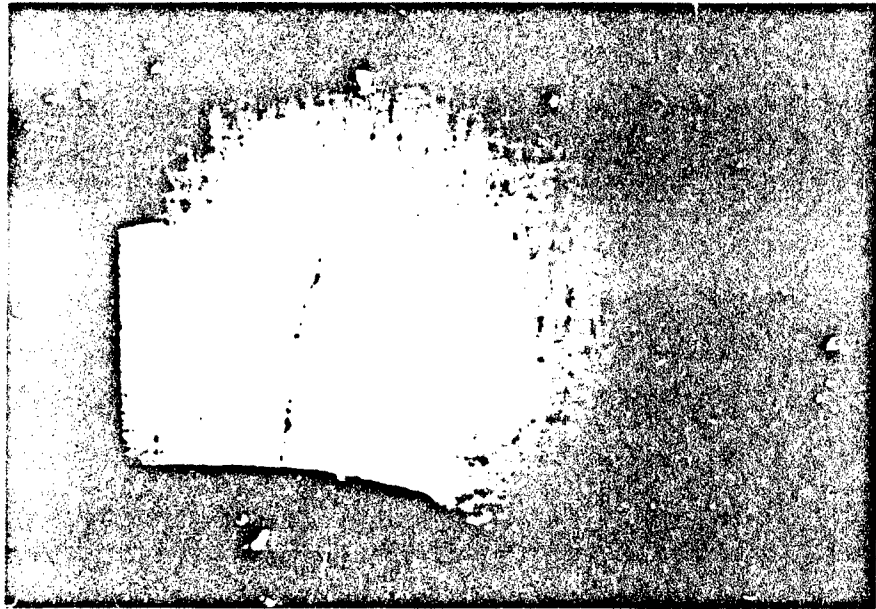
Figure 4. Macrophoto of the crack in Figure 3, showing butt weld and weld overlay.
